From: "McClain, Ian" <IanMcClain@consolenergy.com>
To: "ogmcoal@utah.gov" <ogmcoal@utah.gov>
CC: "SteveChristensen@utah.gov" <SteveChristensen@utah.gov>, "karlhouskee...
Date: 8/4/2009 8:20 AM
Subject: Emery Subsidence report
Attachments: Emery Subsidence 06-2009.pdf

Consolidation Coal Emery Mine Subsidence Report for June 2009

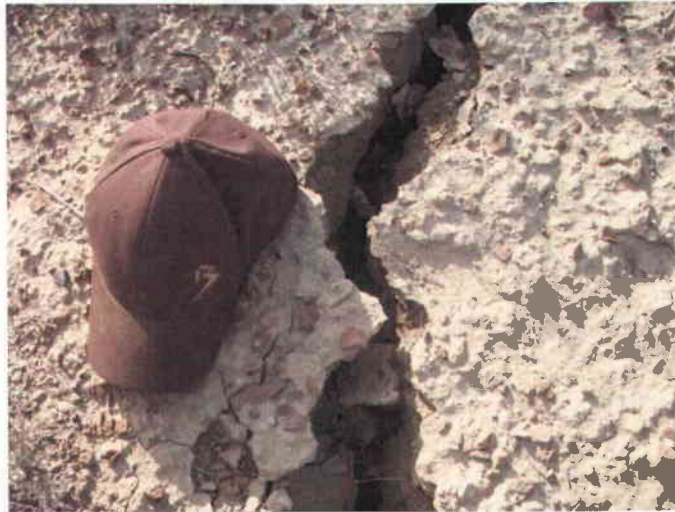
7th West – Was able to GPS subsidence points as well as pictures. Cracks are ranging from ½” to almost 2½” wide. Used ball cap in pictures for scale 7.375” wide cap. JJ

7th West Subsidence crack

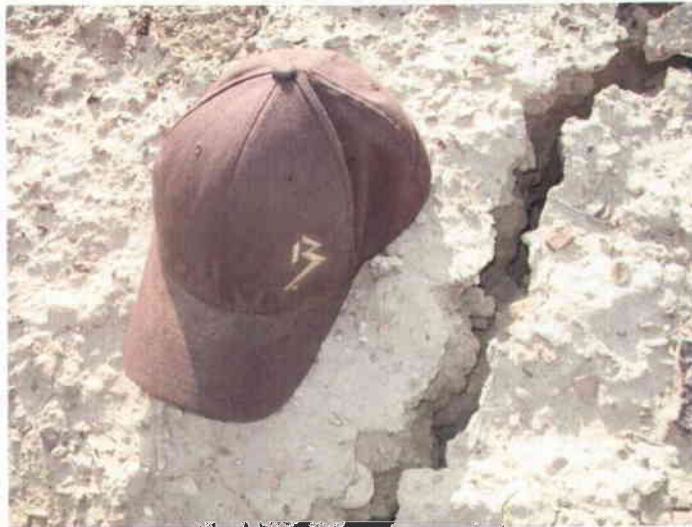
7th West Subsidence crack

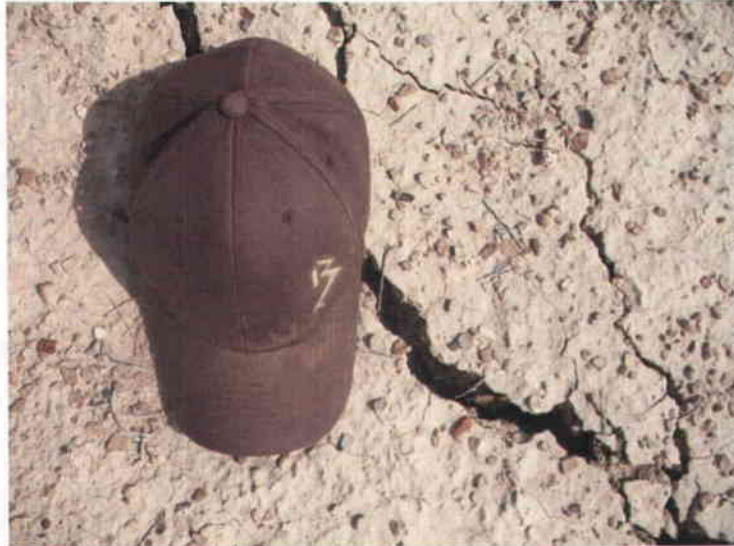
7th West – GPS points and pictures ranging from 0.25" to 1". Used ball cap to scale 7.375" wide and size 10 shoe. Cracks following 7th West panel. JJ

7th West Subsidence crack

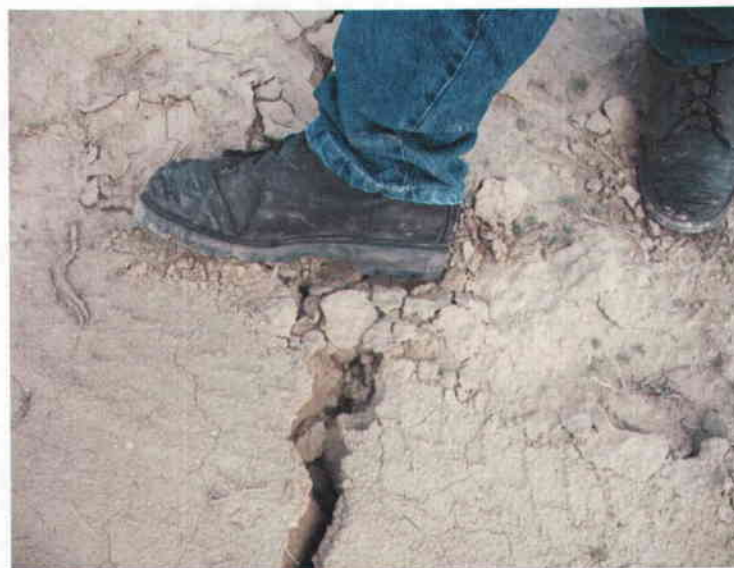
7th West Subsidence crack

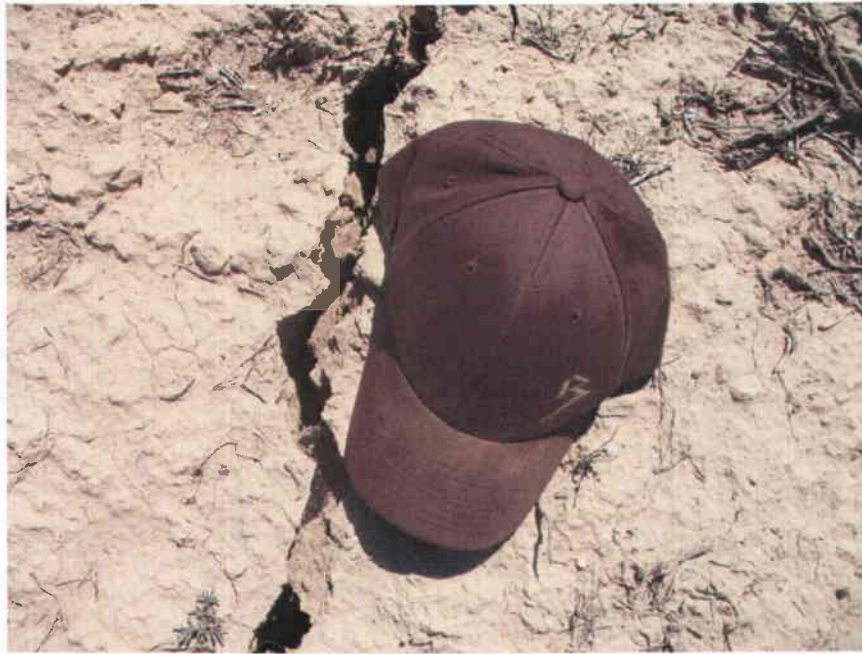
7th West – Took pictures of new cracks used hat for scale. Cracks are ranging 0.5" to 1". Also GPS points. Subsidence is following 7th West section. JJ

7th West Subsidence Cracks

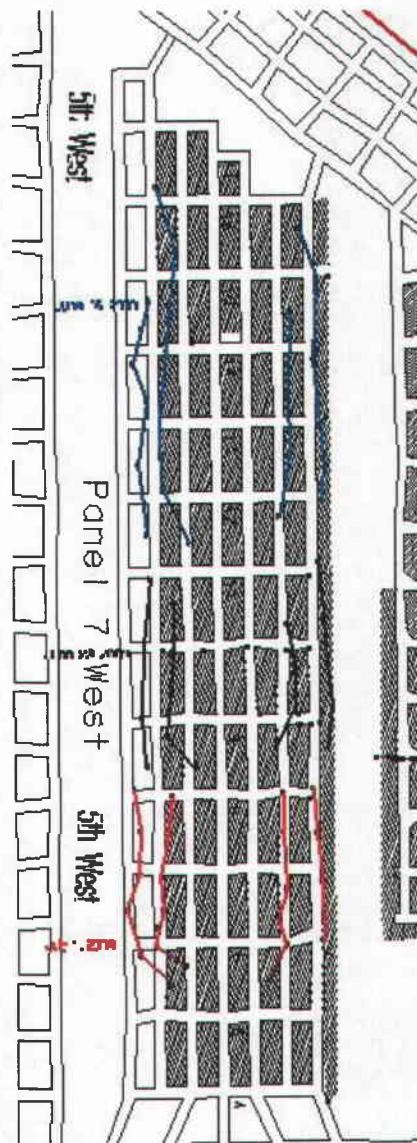
7th West GPS Subsidence Points
